2025 Calendar

A year of
process safety incident
case studies

This calendar of process safety incident case studies was prepared by Peter Davern, Department of Chemical Sciences, University of Limerick, Ireland. All case study descriptions were drafted by referring to or extracting content directly from the following sources.

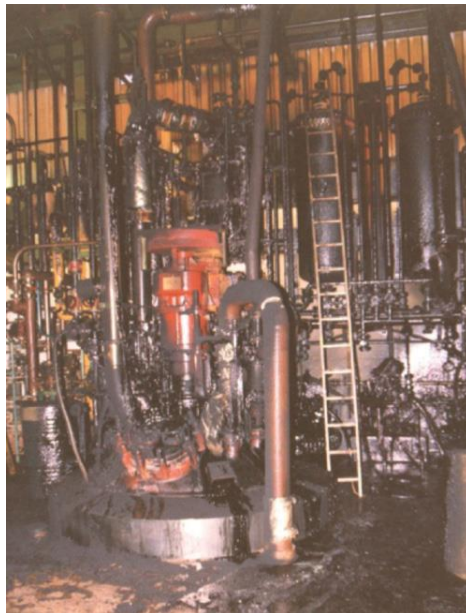
Figure 2: The reactor floor of Building B62, post-incident. Image source: Loss Prevention Bulletin

- The hazardous decomposition was known prior to the incident. The main basis of safety relied on the boiling (and distillation) of aniline to remove the energy released during the decomposition reaction. But there was only enough aniline to remove 20% of this energy.

- Two years earlier, the batch size was increased by 10% in the same reactor; furthermore, the incident batch had a ca. 3% overcharge of one raw material. Cumulatively, both actions caused a small increase in the final temperature of a synthesis reaction already operating in a thermally sensitive region.

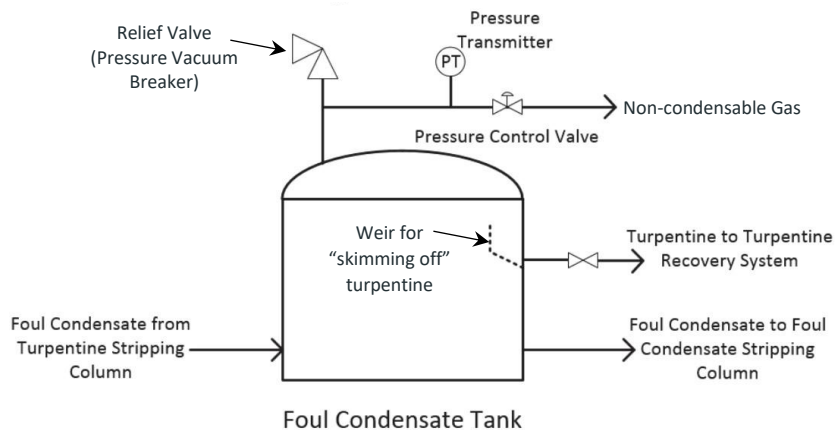
Figure 1: Simplified drawing of the foul condensate tank. The top of the weir (dotted line) sits approximately 6 meters from the base of the tank. As the liquid inside the tank rises above 6 meters, liquid is “skimmed” into the weir and sent to a turpentine recovery system. Image source: U.S. CSB (adapted)

- PCA did not voluntarily apply its process safety management (PSM) system, which was required by OSHA elsewhere in the mill, to the non-condensable gas system that included the foul condensate tank. Thus, no process hazard analysis was ever done, which could have identified the scenario of a flammable atmosphere arising inside the foul condensate tank and thereafter could have defined safeguards to address this scenario, especially when planning hot work.

The merits of (i) applying a PSM system site-wide, (ii) clearly defining roles and responsibilities, and (iii) designing tanks to adequately address foreseeable hazardous scenarios.

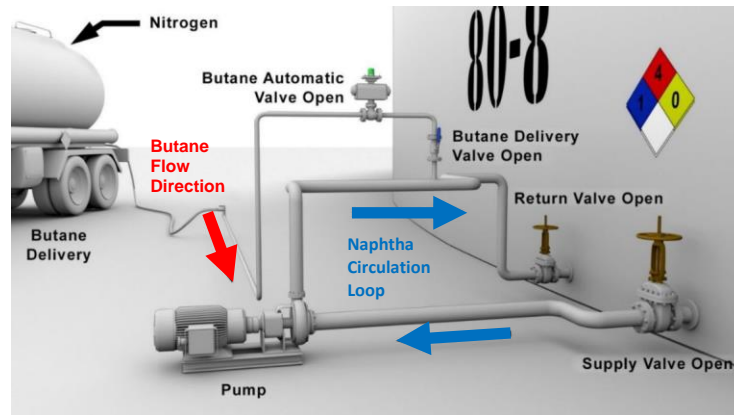
Figure 2: Schematic of ITC's Truck Butane Injection System. Image source: U.S. CSB (adapted)

- ITC did not have a formal mechanical integrity procedure in place to cover Tank 80-8 and its associated equipment, including the circulation pump. The investigation concluded that the pump continued circulating butane-enriched naphtha despite the failure of its outboard bearing. The bearing failure likely led to significant pump vibration, which loosened the gland nuts that secured the mechanical seal in place, causing the seal to separate and allow the release of the flammable mixture.

- Tank 80-8 was not equipped with a flammable gas detection system to alert personnel of a hazardous atmosphere resulting from loss of containment from the tank or its associated equipment. A 2014 hazard review recommended the addition of flammable gas detection systems near Tank 80-8; however, this was never done.

For companies that handle large volumes of flammable or highly hazardous substances, the importance of (i) having multiple preventive and mitigation safeguards in place such that a single safeguard failure does not result in a catastrophic event, (ii) having strategically located gas detection systems, (iii) having appropriate remote isolation capability, (iv) applying tank farm design criteria that facilitate (rather than hinder) emergency response efforts, and (v) applying a process safety management program even when not a regulatory requirement.

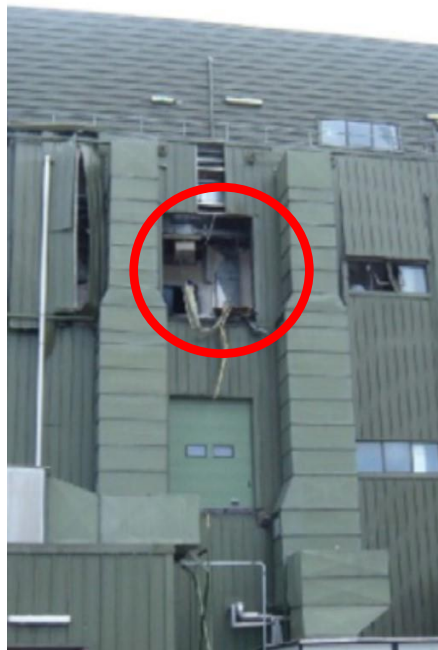
Figure 1: The north side of production Building No. 2 (PB2), post-incident, with the upper roller-shutter door (circled) missing. Image source: Loss Prevention Bulletin

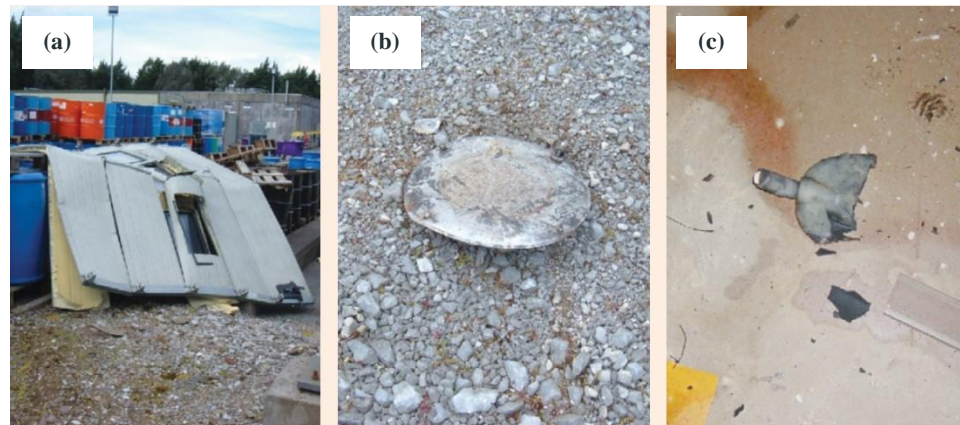
Figure 2: (a) The upper roller-shutter door found on the ground outside PB2 near the drum storage area, (b) the cover of the solids charge chute found on the ground outside PB2, and (c) part of the solids charge chute butterfly valve found on the 3rd floor. Image source: Loss Prevention Bulletin

- The reactor's emergency relief systems were unable to deal with the pressure generated during the runaway scenario. That said, the solids charge chute unintentionally provided additional emergency relief capacity, which may have prevented the catastrophic failure of the reactor.

- Properly conduct HAZOPs of hazardous processes.
- Process control and protection measures should be commensurate with the risk of the related loss of control scenarios.

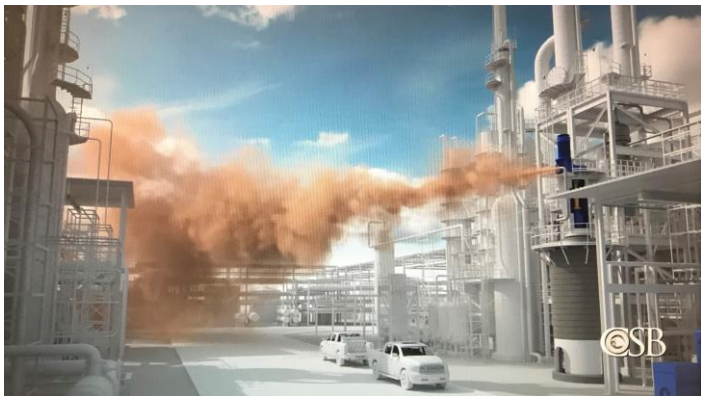
Figure 1: A computer-generated image depicting the horizontal release of ethylene vapour from EVAL Reactor 2's emergency pressure relief system. Image source: U.S. CSB

- A 2015 Kuraray process hazard analysis team recommended upgrading the EOV to allow it to be taken over by the control system and fully opened at pressures above the high-high-pressure alarm; however, this recommendation's implementation had been pushed out to 2019.

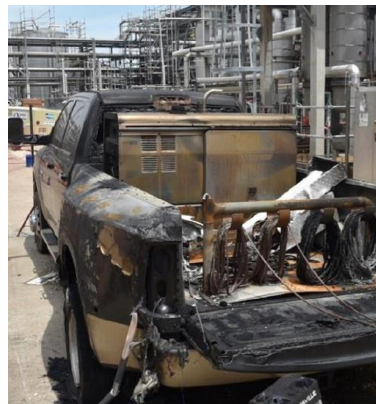
Figure 2: The welding machine on the back of the pickup truck, post-incident. Image source: U.S. CSB

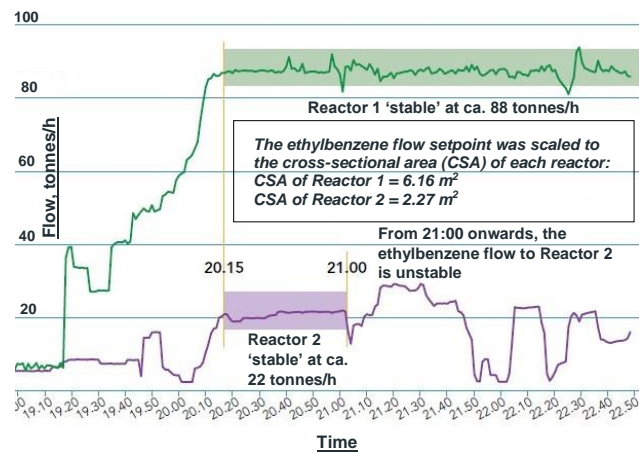
- This was the Panel Operator and the Production Team Leader's first time to start up Unit 4800 after such a pitstop.
- When work instructions were drawn up, some key process parameters defined during Unit 4800's design (e.g., the minimum EB and nitrogen flowrates needed to ensure wetting of the catalyst pellets; having a 30°C/h heating rate) were either not always incorporated or failed to be incorporated in the correct manner. Thus, important information was lost between Unit 4800's design and its ultimate (day-to-day) management.

Figure 2: Circulation flowrate trends for ethylbenzene in Reactor 1 (upper green trend) and Reactor 2 (lower purple trend) during the start-up. Image source: Dutch Safety Board (adapted)

The importance of (i) management of change, specifically here in terms of changes to raw materials and process parameters, and (ii) having suitably experienced personnel in place during start-ups.

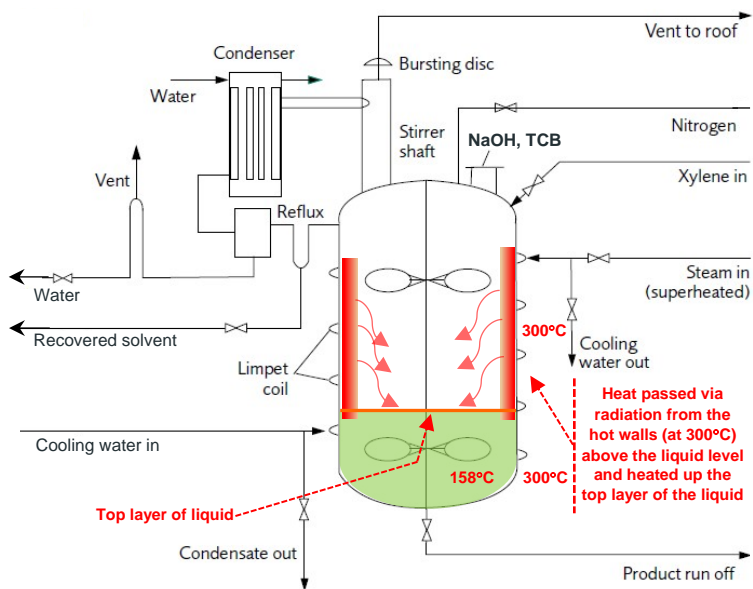
Figure 1: Schematic diagram of the reactor at ICMESA on the morning of the incident following shutdown of the process for the weekend. Image source: Loss Prevention Bulletin (adapted)

- The TCP reactor was not equipped with an emergency relief receiver vessel, perhaps because a runaway was not envisaged given the prevailing processing conditions. However, three runaway reactions in similar plants had occurred prior to the 'Seveso' incident. For example, a runaway and pressure rupture occurred during the production of TCP from TCB and NaOH in ethylene glycol in a batch reactor at Coalite and Chemical Products, Bolsover, UK in 1968. The escaping gases exploded, killing one employee and injuring seven others. In that case, the reactor was heated by hot oil at 300°C and the manual heating control system had failed.

The importance of thoroughly interrogating chemical processes for thermal and reactive hazards, and thereafter (i) defining the maximum temperature for heating media to avoid runaway reactions, and (ii) designing pressure relief systems that exhaust to containment systems, thus preventing hazardous releases to the work and/or external environment.

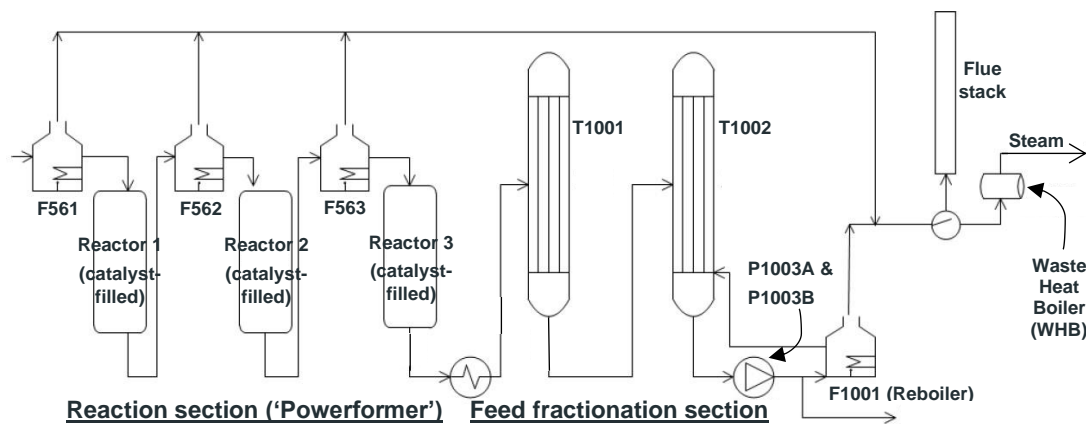
Figure 1: A simplified view of the Powerformer plant showing only the units and detail relevant to this incident. (Figures 1 and 2 have been created by adapting images sourced from the Dutch Safety Board)

- It only emerged days after the incident that the compressor had tripped due to a short circuit in its power cable, and that the same short circuit had also led to a voltage dip in the WHB’s switching station; this caused the WHB’s fan to stop and, ultimately, the WHB to fail. It is possible that the field operator mistook the wind-down of the WHB’s fan (as it stopped) as evidence the fan was still running.

- Thereafter, the failed WHB was unable to deal with the restored flow of furnace exhaust gases, thus triggering the ‘high pressure cut-out’ which tripped all six furnaces. Only at that point did it become clear that the WHB’s fan had stopped, but not why it had stopped. Despite this, instructions were still given to ‘hot restart’ the furnaces – the WHB was not essential for the Powerformer plant to operate because exhaust gases could anyway be routed to the flue stack while troubleshooting the WHB’s fan issue.

- The tripping of all six furnaces decreased the heat supply to other parts of the Powerformer plant. Among other things, this caused T1001’s distillation performance to deteriorate such that the proportion of heavy fractions increased. Downstream, this ultimately put more pressure on P1003B, which initially overheated and then failed, thus triggering F1001 to trip on ‘low-flow cut-out’. The operator (busy warming up and stabilising the plant) likely did not deem P1003B’s failure a high enough priority since P1003A was on automatic standby. However, unknown to the operator, P1003A was under maintenance and thus not available. Therefore, not linking F1001’s trip to P1003B’s failure, the operators restarted F1001’s burners, but with its low-flow protection still manually bypassed. F1001’s fluid coil duly overheated without a steady flow of product fluid through it, and then ruptured. Product fluid leaked from the ruptured coil (called a ‘split tube’) and ignited inside F1001. Thereafter, most of the contents of T1002 drained into F1001 through the ruptured coil and fuelled the fire.

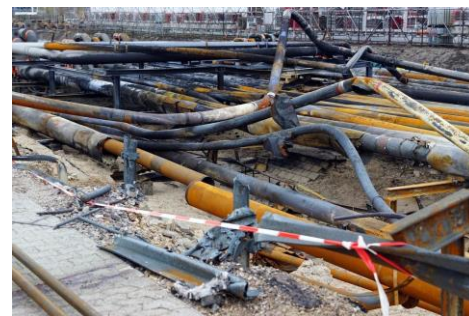
Figure 3: A section of the pipeline trench, post-incident. Image source: Fränkische Nachrichten

On the Friday before the incident, a hand-held auger was used to perforate a 3-mm hole in the propylene pipeline due for repair, and measurements taken using a portable gas detector confirmed the absence of a hydrocarbon-related explosive atmosphere. Several cut-outs were then made in the propylene pipeline and a number of pipe pieces were removed from a U-shaped expansion loop and also from the pipeline on one side of the expansion loop. On the following Monday (the day of the incident), the work was proceeding on the other side of the expansion loop when an angle grinder inadvertently cut into a 'live' pipeline next to the propylene pipeline under repair; this live pipeline contained a butylene mixture under 4 bar pressure. The butylene mixture escaped via the cut left in the line and ignited due to the sparks produced by the angle grinder. The flames heated the adjacent ethylene pipeline (88 bar, approximately 250 mm diameter) until it burst by fast decomposition, causing a massive explosion with a 200 m fireball and a mass fire.

The importance of maintaining a heightened awareness of nearby hazards when undertaking non-routine and/or intrusive work on isolated plant within a live plant environment; and thereafter implementing measures to control adequately these hazards – for example, of relevance to this incident, the systematic prior labelling of pipework cut-out locations.

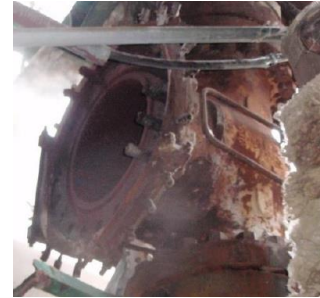
Figure 5: The valve, post-incident, showing the absence of the bonnet. Image source: Team / Total

- The diameter of the RTJ groove in the bonnet flange was 5 mm too small; the acceptable ASME tolerance is 0.13 mm. Therefore, the standard RTJ metal ring did not fit properly into the groove. This meant that extra torque had been applied to several stud bolts to create the desired (leak-tight) parallel flange connection. Thus, these over-torqued stud bolts had stresses close to the minimum yield (ca. 600 N/mm² at 300°C). The over-torquing may also have caused micro-cracks to develop due to 'galling'⁽³⁾.

- The joint leaked on one occasion during its period out of service and a re-injection of sealant was performed. Thereafter, with the valve still out of service (pressurised but cold), a minor leak re-occurred inside the flange-clamp assembly. This created a wet corrosive environment which caused several stud bolts to start corroding and also to become more susceptible to stress corrosion cracking, SCC⁽⁴⁾. Then, when the joint leaked several times following its return to service (at high temperature and pressure) at the end of 2011, the leaked boiler water inside the hot flange-clamp assembly evaporated, leaving behind a corrosive residue of caustic (sodium hydroxide, NaOH) on the already corroding stud bolts⁽⁵⁾. Thus, all the conditions needed for the rapid degradation of the stud bolts via SCC were now in place, namely: high stress, a corrosive medium (NaOH), a susceptible material, and a high enough temperature (>70°C). On the day of the incident, the additional stress from the re-injection process was enough to trigger the failure of the one or more of the (by now) severely degraded stud bolts. This caused stress on the weakened bolts nearby, prompting a chain reaction of overload and fracture of all 20 bolts (Figure 8) that culminated in the bonnet's separation from the valve body, and then the BLEVE.

- Visual inspection is not conclusive regarding the condition of stud bolts.
- Stud bolts in good condition can (under the right circumstances) degrade rapidly due to SCC.
- When risk assessing a re-injection process, pay added attention when the condition of the stud bolts and the stresses on them are unknown.
- Pay particular attention to (i) recurring leaks on live boiler water systems because caustic residues may develop on the stud bolts if the leaked water evaporates within the flanged assembly, and (ii) the build-up of white solid deposits on bolts and/or flanges.
- Leak-sealing clamps are temporary repairs; replace them with permanent repairs at the first opportunity, e.g., a planned outage or turnaround.
- Injecting sealant into leak-sealing clamps can increase the tensile stress on stud bolts by 10 – 20%.

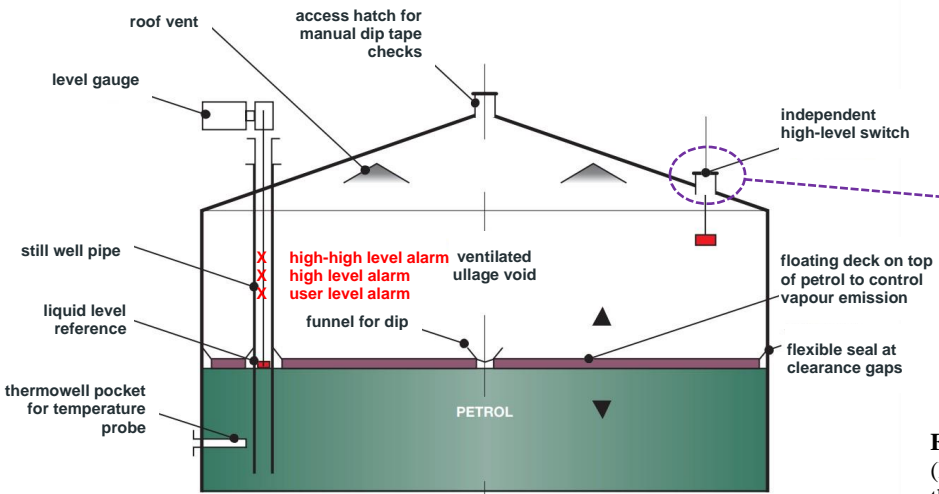
Figure 1: Schematic of Tank 912 – the three level alarms (each shown with a red X) are included for illustrative purposes only. Image source: BMIIB (adapted)

- Tank 912's level display 'flat-lined' at two-thirds full because the tank's level gauge had stuck. It had stuck 14 times in the previous 3½ months; when it did, supervisors either managed to rectify the problem or called an external maintenance contractor to do so. That said, the definitive cause of the sticking had never been identified.

- For a hazardous process, ensure the effectiveness and independence of the various layers of protection. In this incident, the three level alarms were not independent of the level gauge; thus, the alarms could not activate once the level gauge stuck at a level below the alarms' setpoints.

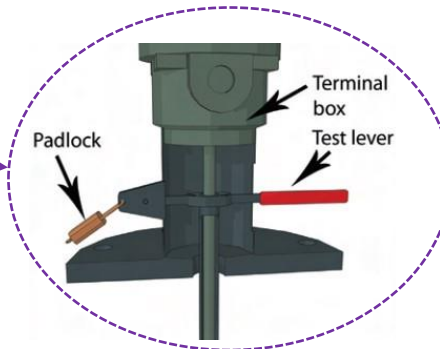
Figure 2: Detail of the independent high-level switch (IHLS). For the IHLS to function, the test lever must be in the horizontal position as shown. Without the padlock in place, the test lever would drop from the horizontal and render the switch inoperable. Image source: HSE (UK)
