2025 Calendar

A year of
process safety incident
case studies

This calendar of process safety incident case studies was prepared by Peter Davern, Department of Chemical Sciences, University of Limerick, Ireland. All case study descriptions were drafted by referring to or extracting content directly from the following sources.

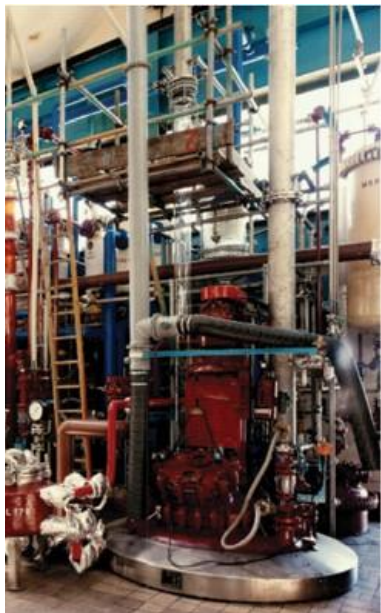
Figure 1: The reactor floor of Building B62, pre-incident. Image source: Loss Prevention Bulletin

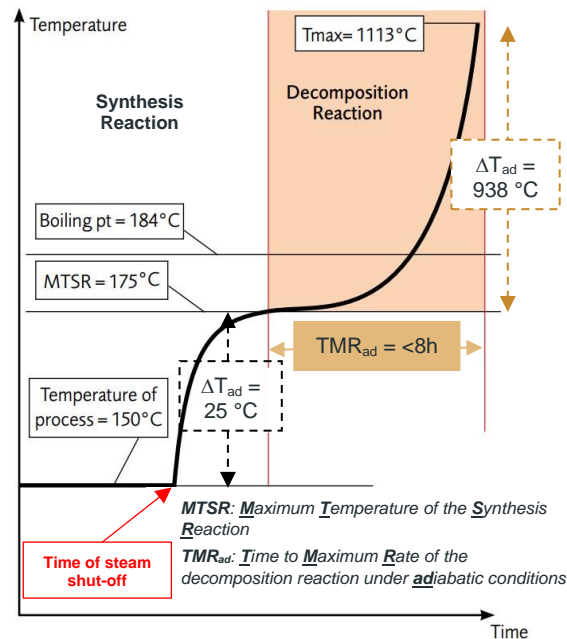
Figure 3: Graphical summary of the thermal risks for the synthesis reaction; note – the axes are not to scale. Image source: Loss Prevention Bulletin (adapted)

- Starting from a given MTSR, the time for a decomposition reaction to reach thermal runaway (TMR_{ad} , Figure 3) is a measure of the likelihood of triggering the decomposition. If TMR_{ad} is >24hours, the likelihood of triggering the decomposition reaction is deemed low. Here, the TMR_{ad} was calculated to be <8 hours for the MTSR of 175°C, meaning a high likelihood of triggering the decomposition reaction.

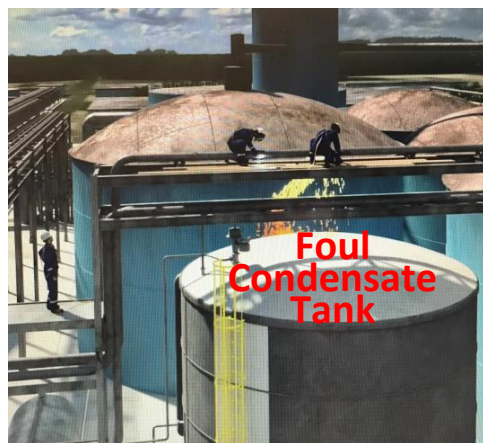
Figure 2: A computer-generated image depicting the hot work being performed on the pipework above the foul condensate tank. Image Source: U.S. CSB (adapted)

- PCA did not voluntarily apply its process safety management (PSM) system, which was required by OSHA elsewhere in the mill, to the non-condensable gas system that included the foul condensate tank. Thus, no process hazard analysis was ever done, which could have identified the scenario of a flammable atmosphere arising inside the foul condensate tank and thereafter could have defined safeguards to address this scenario, especially when planning hot work.

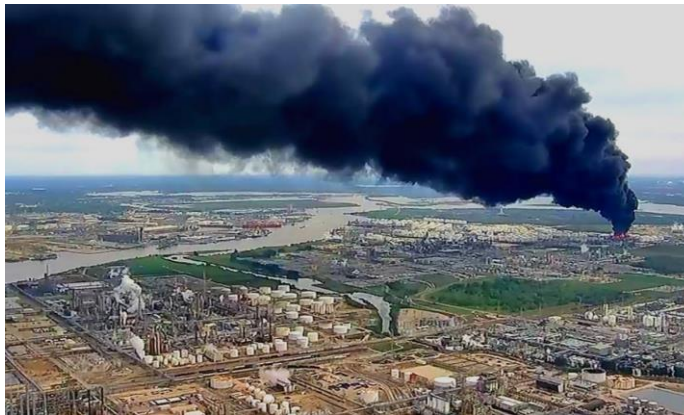
Figure 1: Plume of black smoke rising from ITC's tank farm fire. Image source: U.S. CSB

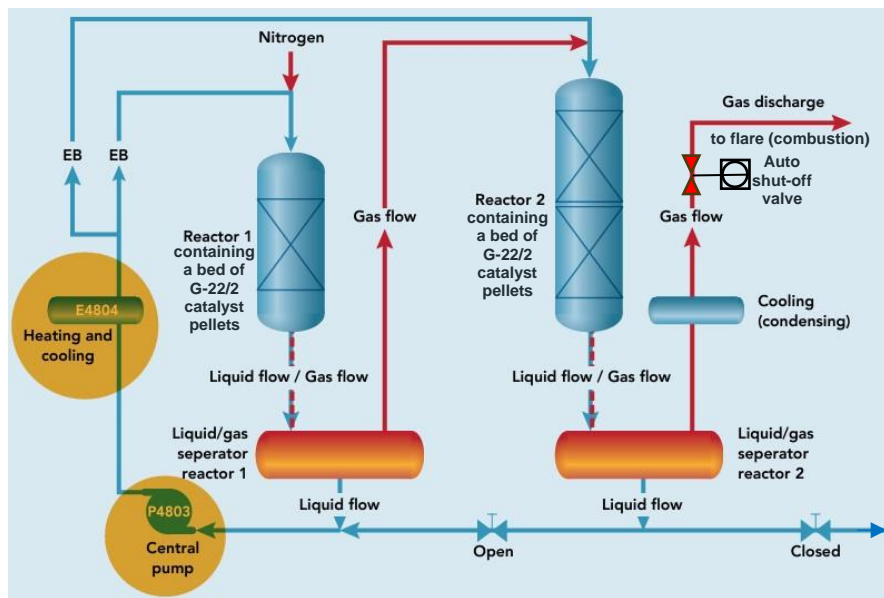
Figure 1: MSPO2's Unit 4800 during the circulation and heat-up steps; EB = ethylbenzene. Image source: Dutch Safety Board (adapted)

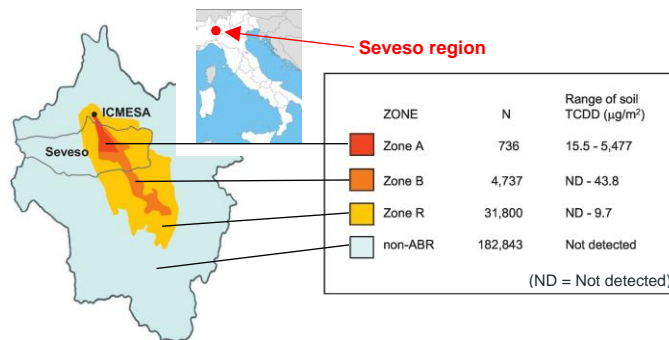
Figure 2: Map of the Seveso region showing the number of residents (N) and TCDD soil level ranges (µg/m²) in the post-incident zones of contamination A, B, R and non-ABR. Image source: Eskenazi *et al.* (adapted)

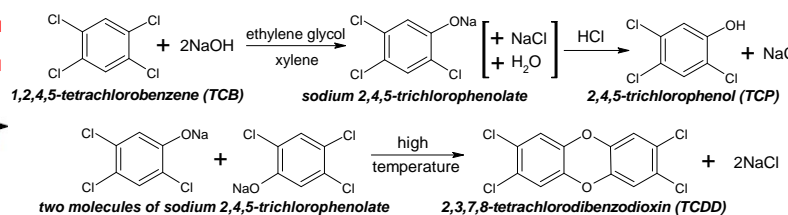
Figure 3: The desired two-stage process (top) and undesired reaction (bottom)

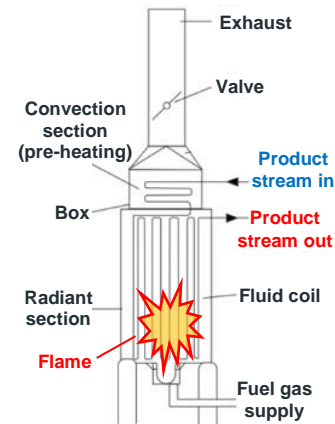
Figure 2: A diagram of a Powerformer plant furnace.

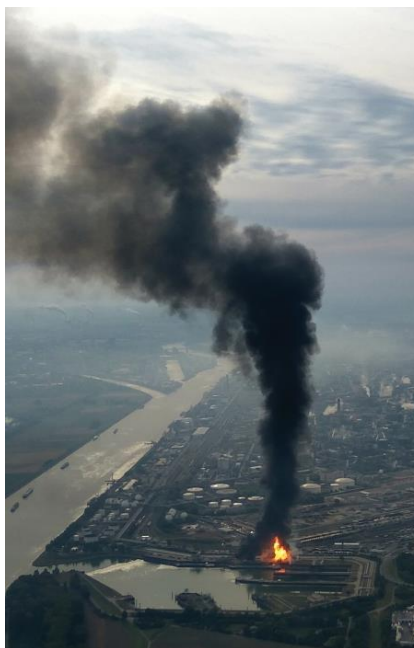
Figure 1: The pall of smoke rising from the fires at the North Harbour of BASF's Ludwigshafen site. Image source: C&E News

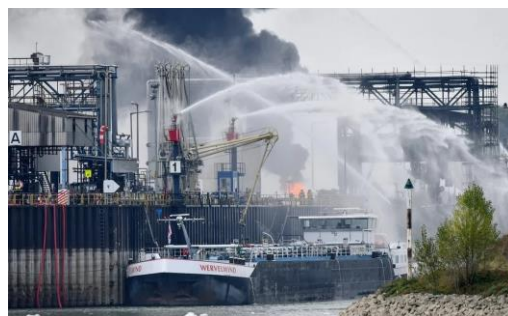
Figure 2: Hours after the initial explosion at Ludwigshafen, the fire at the harbour was still burning. Image source: BBC News

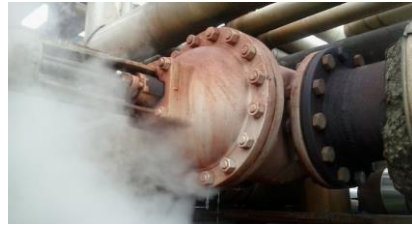
Figure 2: A bonnet / valve body flange with a steam leak. Image not related to this incident. Image source: <https://leaksealing.com/>
